USACERL Interim Report FM-93/05
December 1992
Roofing Materials Degradation Processes

Three-Year Field Test Summary for Experimental Modified Bitumen Roofing at Fort Polk, LA

by
David M. Bailey
Walter J. Rossiter
James F. Seiler, Jr.

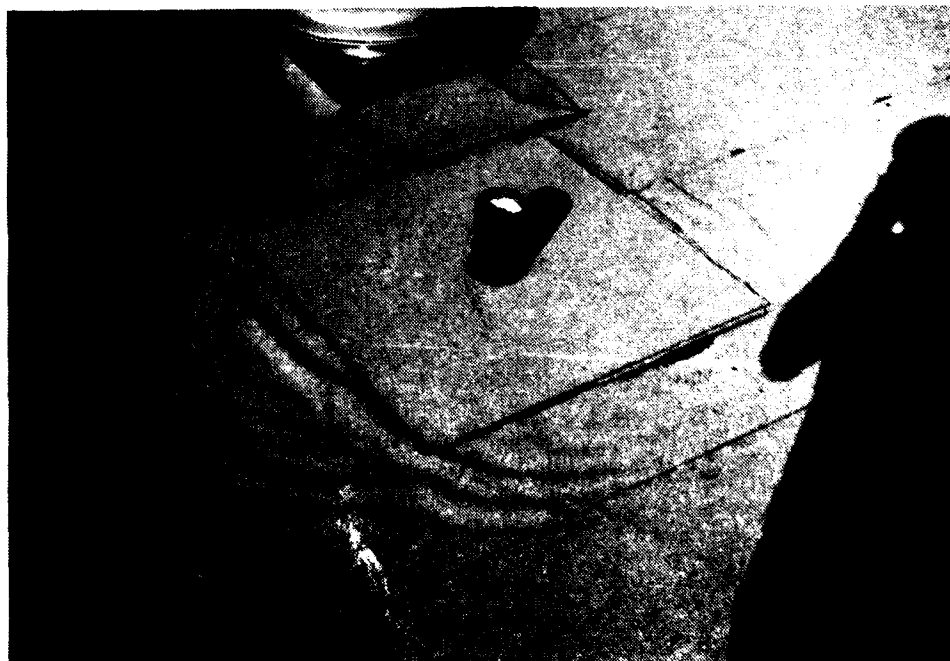
The first evidence of slippage was the gap of exposed mopping asphalt running perpendicular to the slope and located at the uppermost part of the roof section (Figure 12). The gap was approximately 4 in. wide and tapered to zero width at the south wall and north area divider. Wrinkles and fishmouths in the membrane lap seams had occurred at locations where the slippage was prevented by roof penetrations (Figure 13).

Figure 13. Wrinkles and Dishmouths due to Slippage.

To complete the procedure, the wrinkles and fishmouths located around the penetrations were cut and removed, and patched with new membrane material.

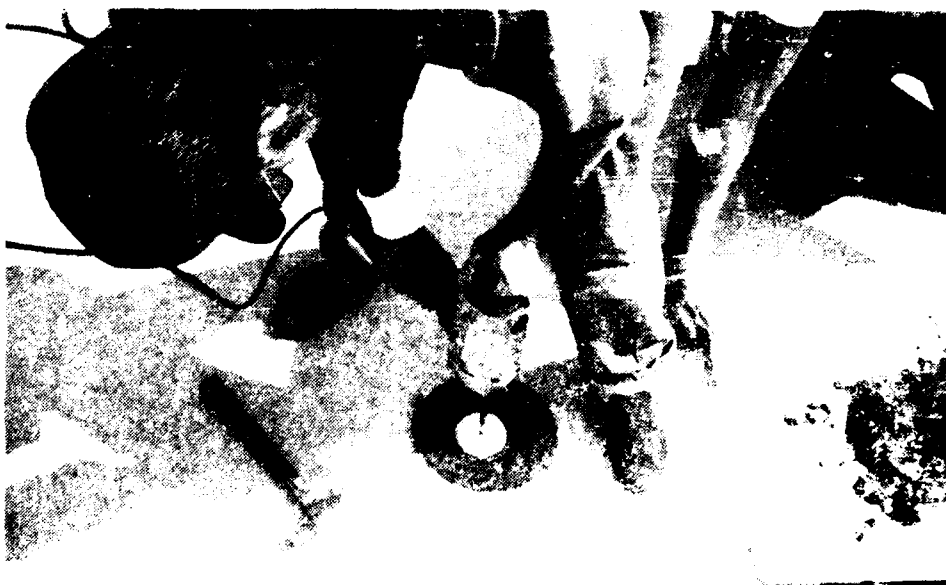
Figure 15. Placing the Fasteners Through Membrane B.

1. A 9-in. circle was drawn at the fastener location using a template.
2. With the assistance of a heat torch, the mineral granules within the circle were spudded away.
3. A 3-in. diameter metal plate was placed in the center of the circle and a steel screw fastener was driven through the plate and into the metal deck below (Figure 15).
4. The membrane surface within the circle, metal plate, and fastener head were primed and the solvent was allowed to dry before proceeding to the next step.
5. The underside of a 9-in. diameter circular patch of membrane material was heated with a torch, placed over the target area, and adhered, and
6. Using the torch and a trowel, the edges of the patch were sealed with modified bitumen (Figure 16).
